Bennington State Office Building TBS Diagnostic Results Summary

08-02-07

Turner Building Science & Design, LLC

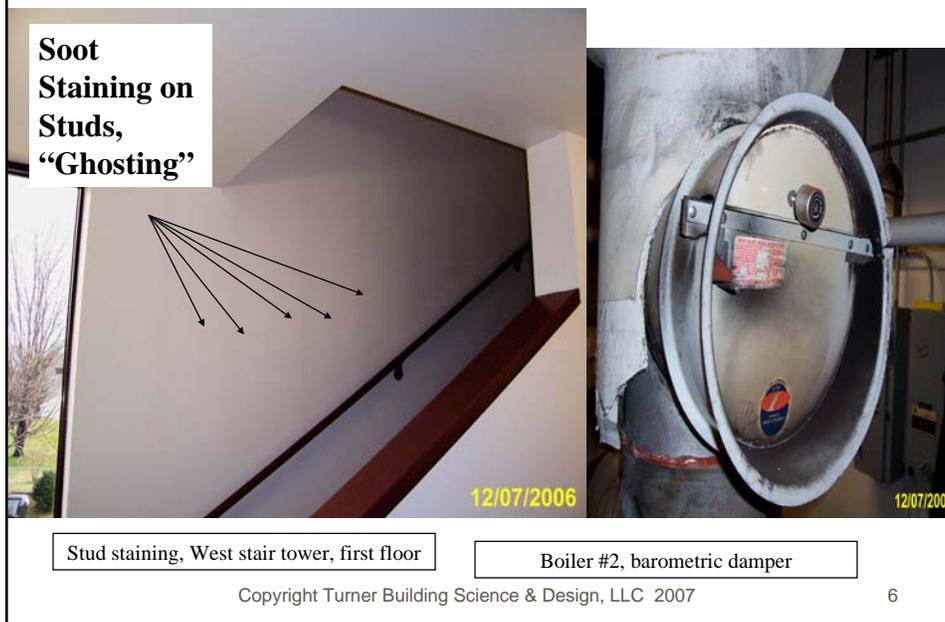
Staining / Soot

■ **Results:** Visual Staining in stairwell. Lab analysis confirmed boiler soot on air filters & deposited throughout the facility . Rather unusual finding. Calculations and Tracer confirm dissemination pathways.

■ **Info. Appendix. #B1, C4, D4**
C.A.R.: #2,#7,#4 Replace the Boiler System, Seal Gross Air Leakage, Clean The Ducts.

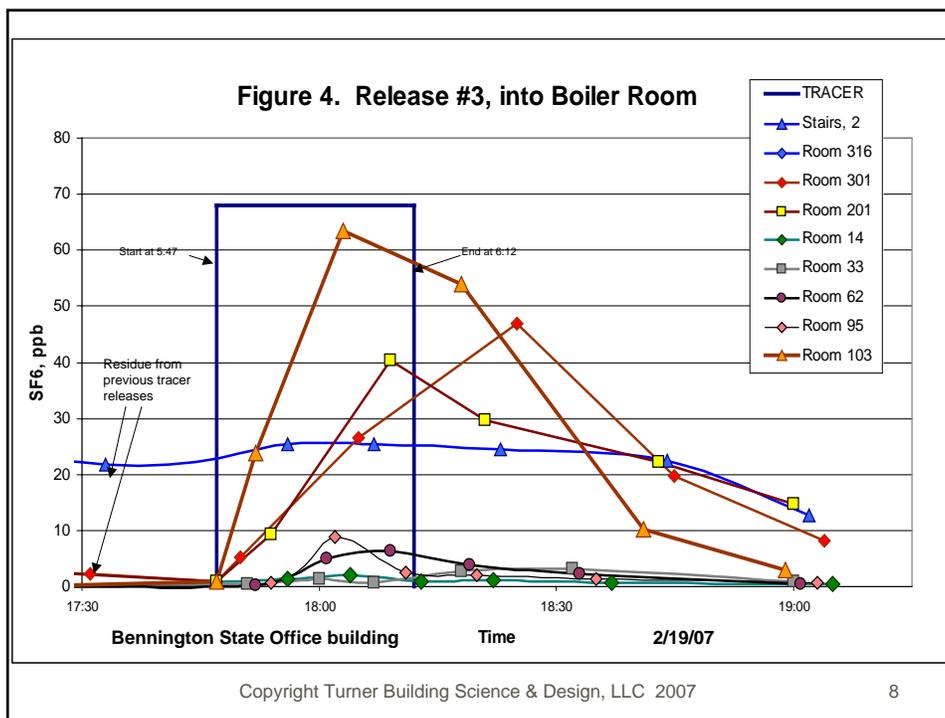
- **Results:** Pathways confirmed, air moved into facility almost instantly, then moved to all three floors within 10 minutes.
- **Info. Appendix. #C3, Figure 4**
C.A.R.: #2, #7 Replace the boiler, seal gross air leakage.

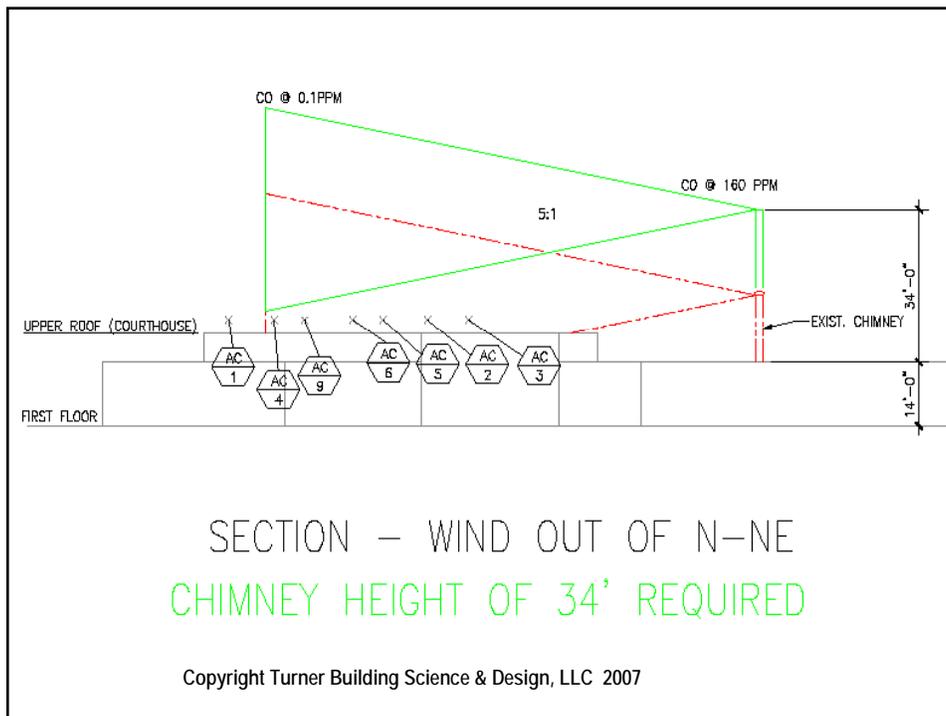
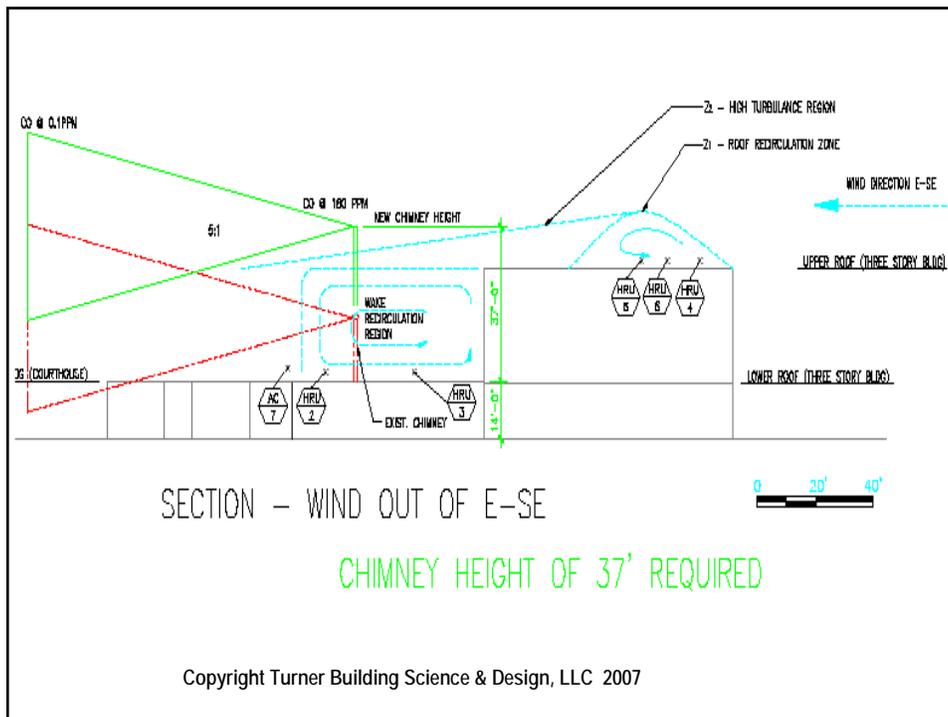
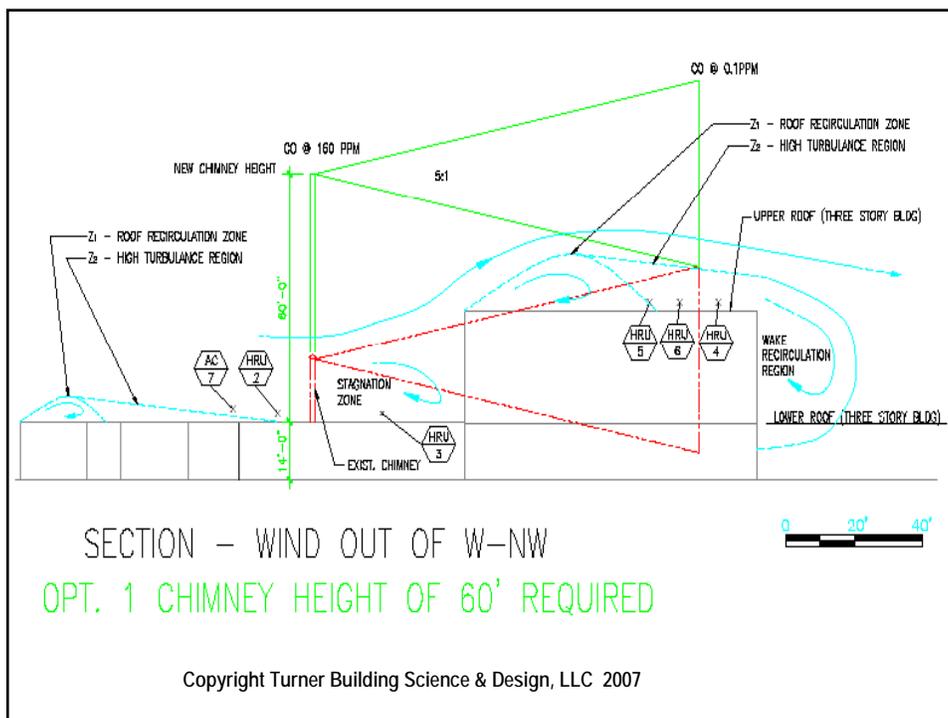
- **Results:** Current boiler stack location not suitable. Needs to discharge way above level of top floor to stop reentrainment.
- **Info. Appendix. #D4**
C.A.R.: #2, #7 Replace Boilers, Fix Gross Air Leaks.

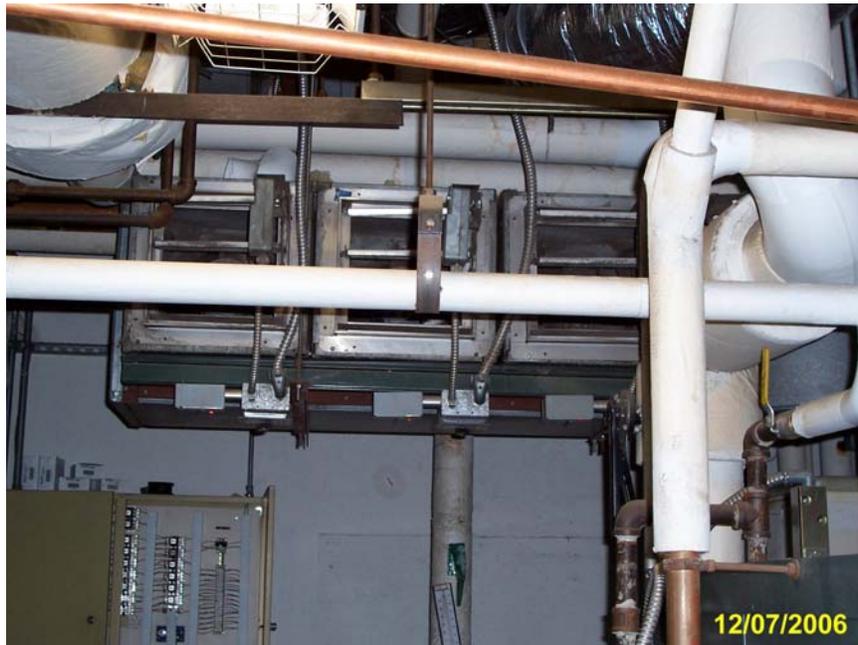
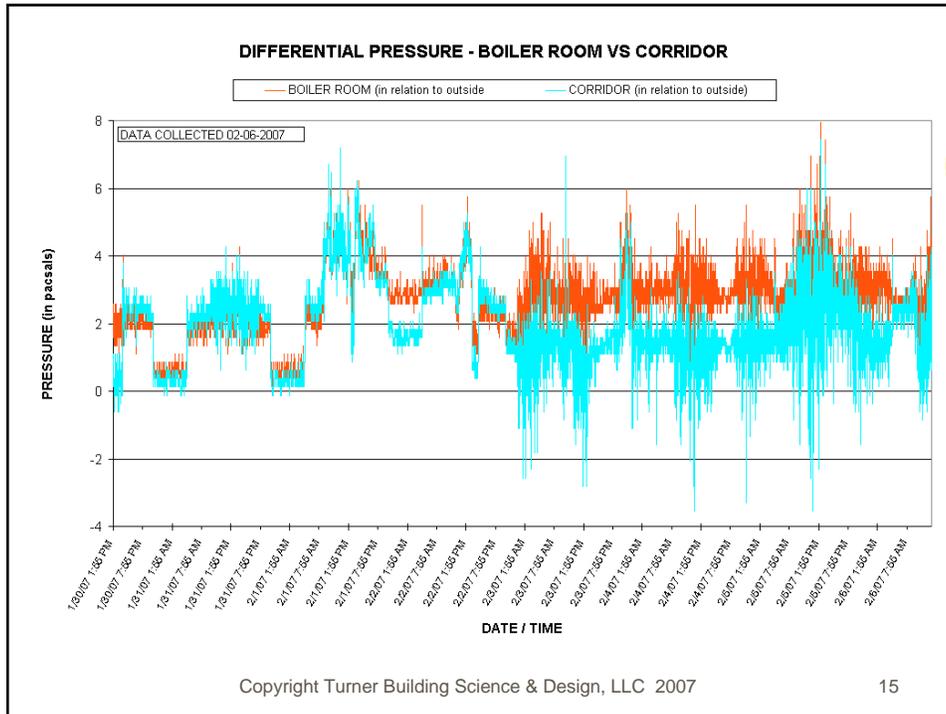
- **Results:** Current boiler room pressure in wrong direction, current make-up air controls abandoned.
- **Info. Appendix. #C4**
C.A.R.: #2, Replace Boilers, move boiler room? or computer monitor and control pressures?.

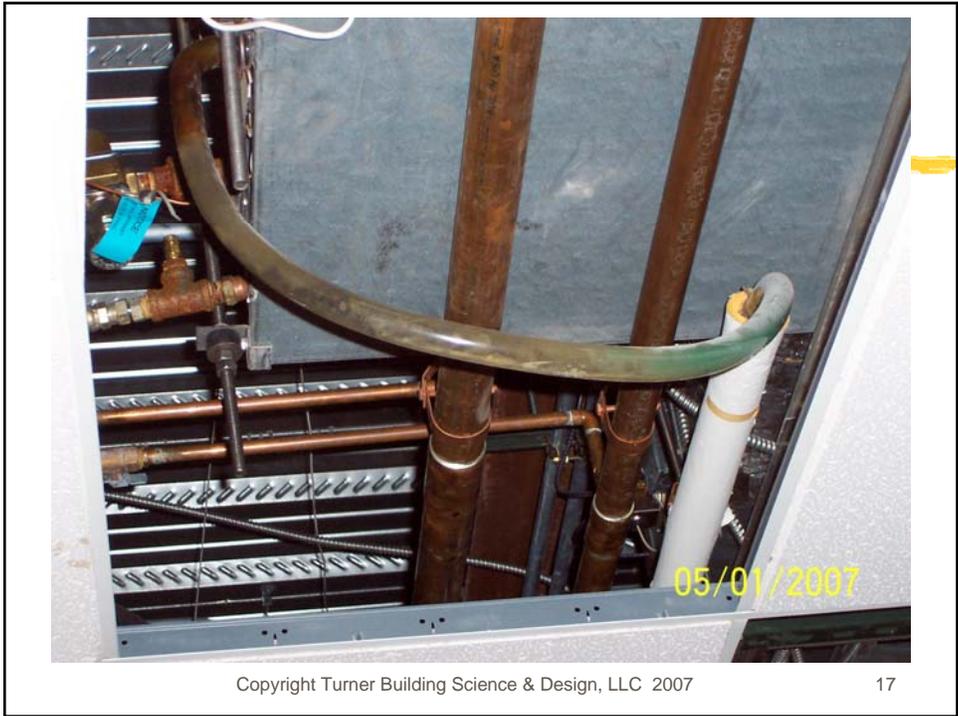
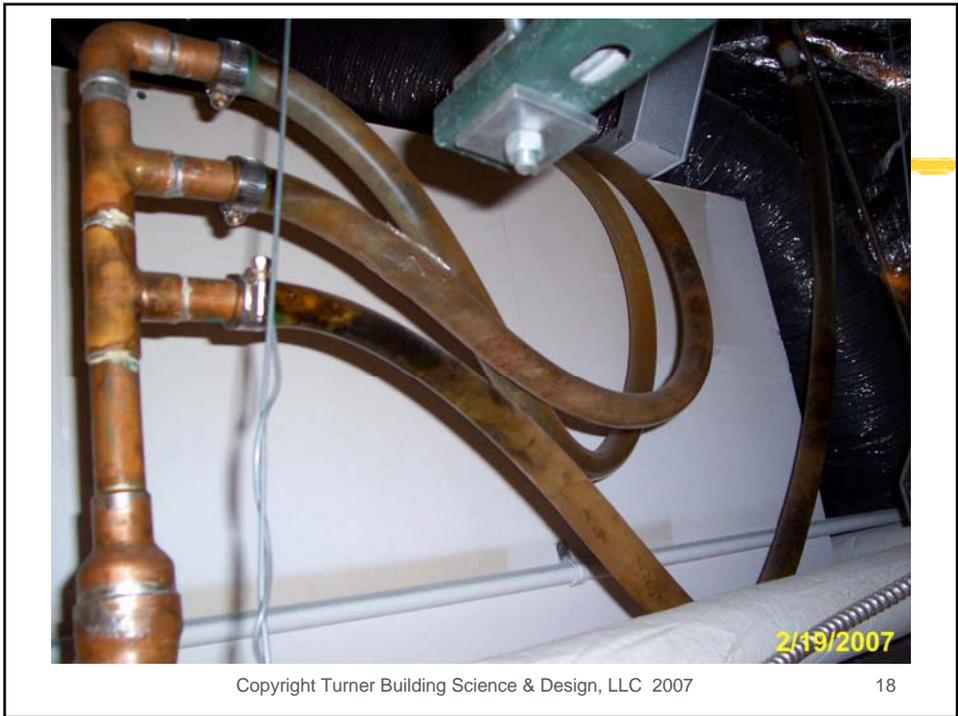
- **Results:** Multiple reservoirs located throughout the facility, dissemination pathways exist. Sec. 3.11, 3.12, 3.13
- **Info. Appendix #B 5,6,7 C3, E4, E5**
- **C.A.R: #1 Replace the HVAC System, also #5, #6, #9 #10**

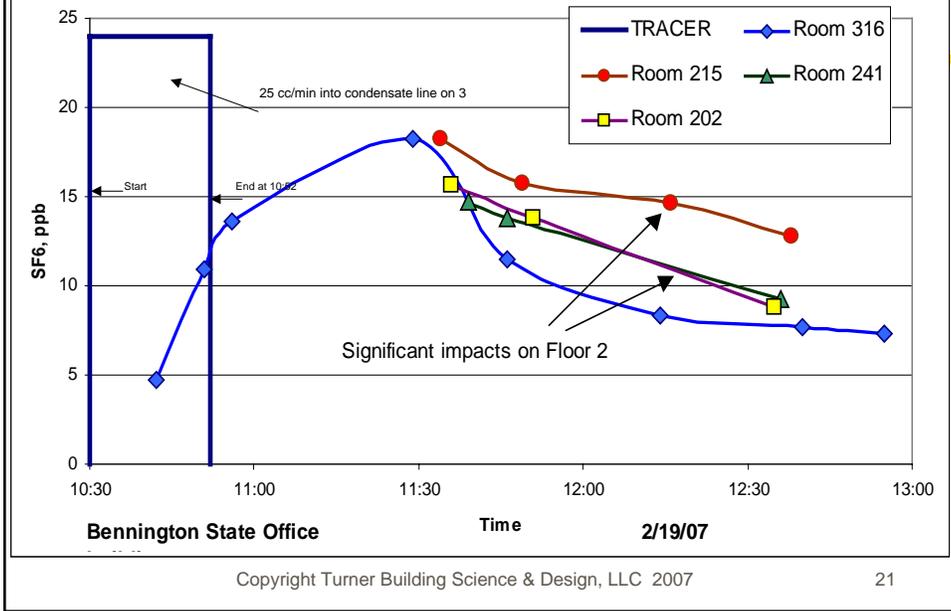
Figure 2. Tracer release #1 into Condensate Line on Floor 3

- **Results:** Multiple pathways confirmed, air moved into facility almost instantly in both drain lines tested 3rd and 2nd floor, then moved to other two upper floors within 20 minutes.
- **Info. Appendix. #C3, Figure 1,2,3**
C.A.R.: #1, #10 Replace the HVAC Systems, clean the facility.

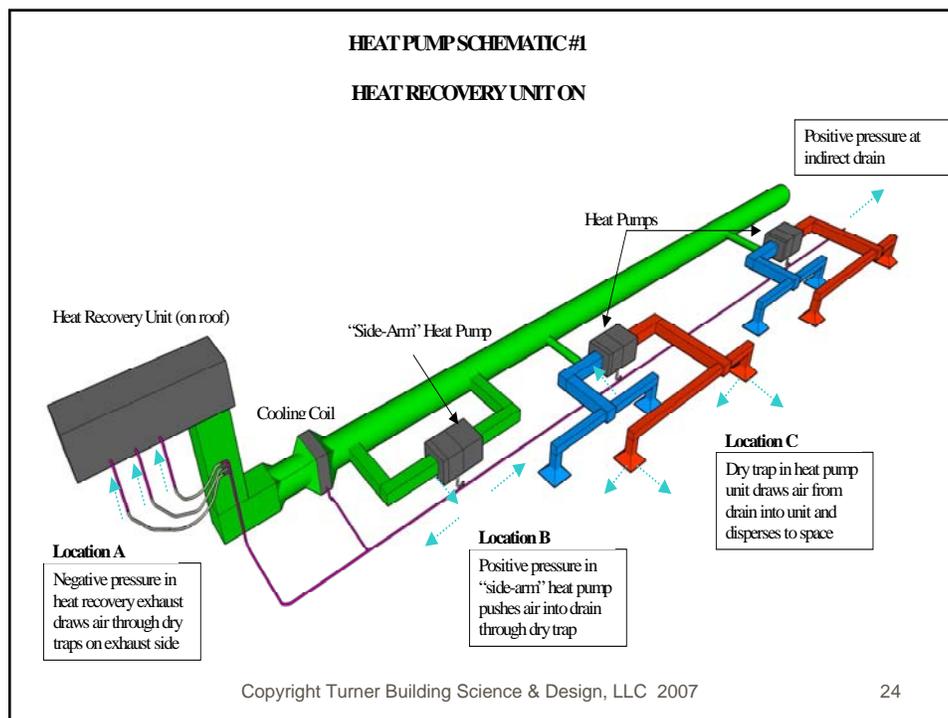
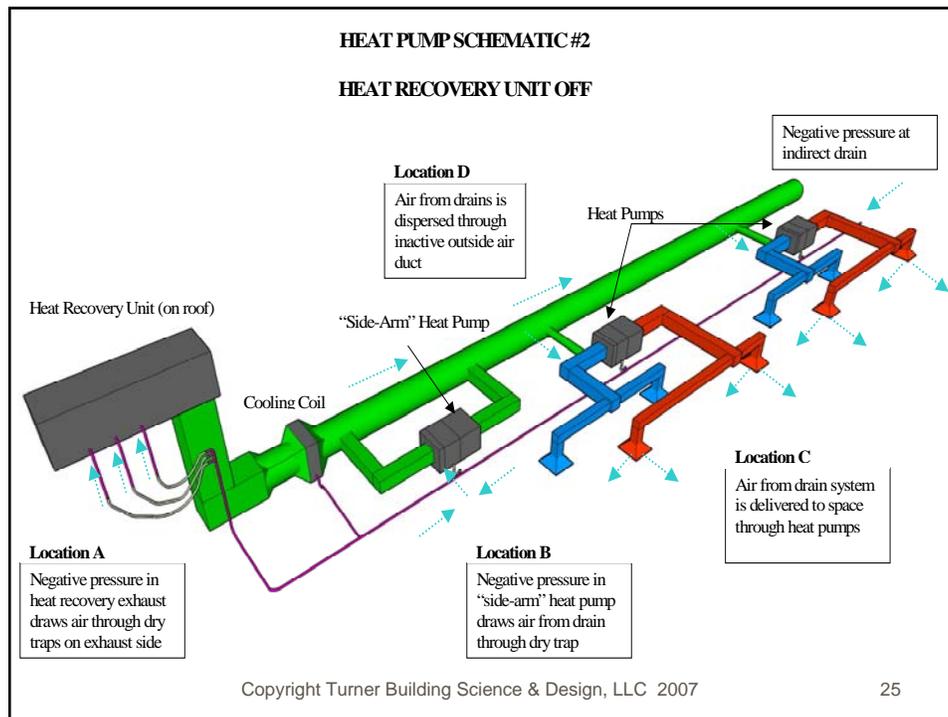
- **Results:** Multiple pathways airflow mapped, three primary routes for routine microbial dissemination.
- **Info. Appendix. #D3, Schematic 1 & 2**
C.A.R.: #1, #10 Replace the HVAC Systems, clean the facility.

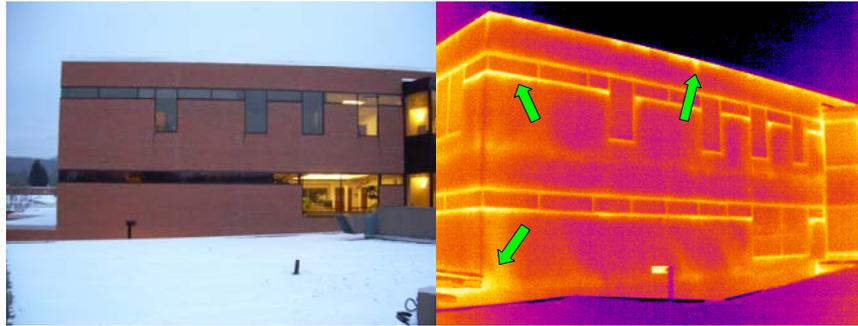
Infrared (Exterior Photo)

- **Results:** Infrared Thermography finds lots of air leaks and suspect wet wall moisture areas.
- **Info. Appendix. #C1**
C.A.R.: #7, Professionally seal multiple gross air leakage sites, (conforms with IPM for cluster flies).

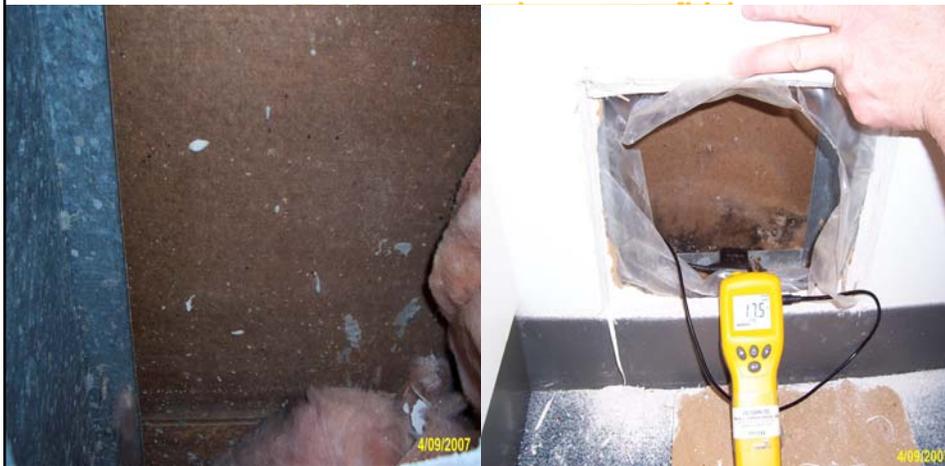
Intrusive Disassembly Photo's 1978 Building

- **Results:** Disassembly and moisture meter confirm some walls wet. Old facility not built as drawn Gypsum vs. CDX plywood behind brick veneer. New facility very minor issues.
- **Info. Appendix. #C6**
C.A.R.: #5,#6,#8 Rebuild (from inside)
1978 walls and windows, fix other areas
1991.

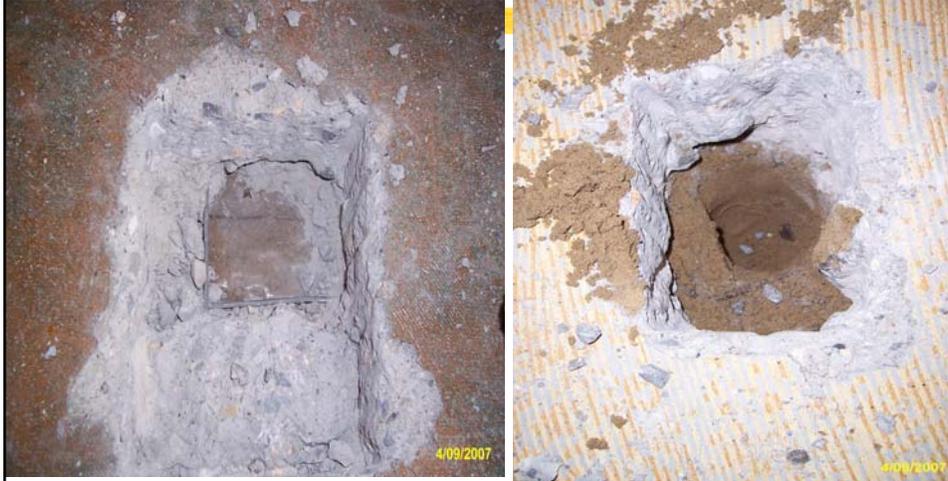
- **Results:** Disassembly of both floors confirmed vapor barriers as designed, some dampness from past flooding? Ongoing exterior wetting. New facility, only very minor issues.
- **Info. Appendix. #C7**
C.A.R.: #9 Fix exterior wetting 1978.

Concrete Slab - Hole Cutting Vapor Barriers Present As Designed

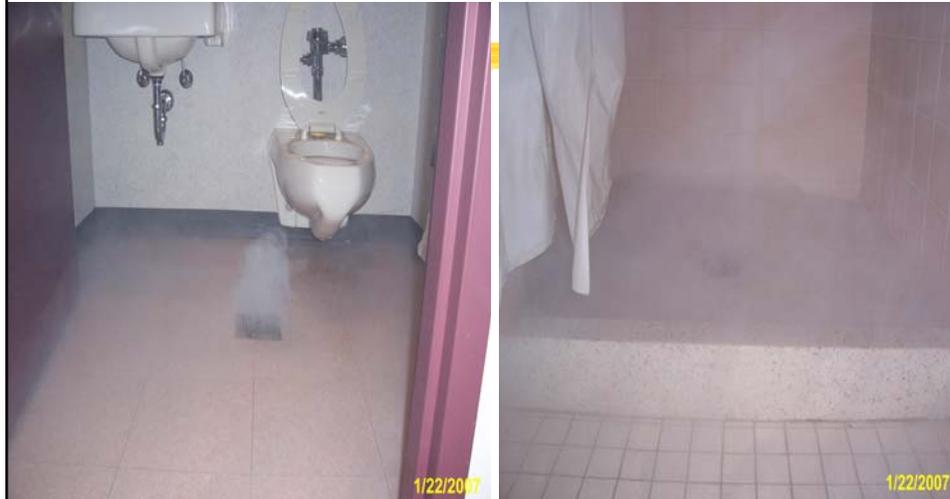
- **Results:** *Good News:* No hidden leaks in walls or above ceilings. *Not so good news:* eighteen dry traps located.
- **Info. Appendix. #C2**
C.A.R.: None Specified, Common issue in some buildings. Improved maintenance? trap primers? .

Theatrical Smoke @ Sewer Vents

Emerging from dry trap

Emerging from shower stall
