Bennington State Office Building TBS Diagnostic Results Summary

08-02-07

Turner Building Science & Design, LLC

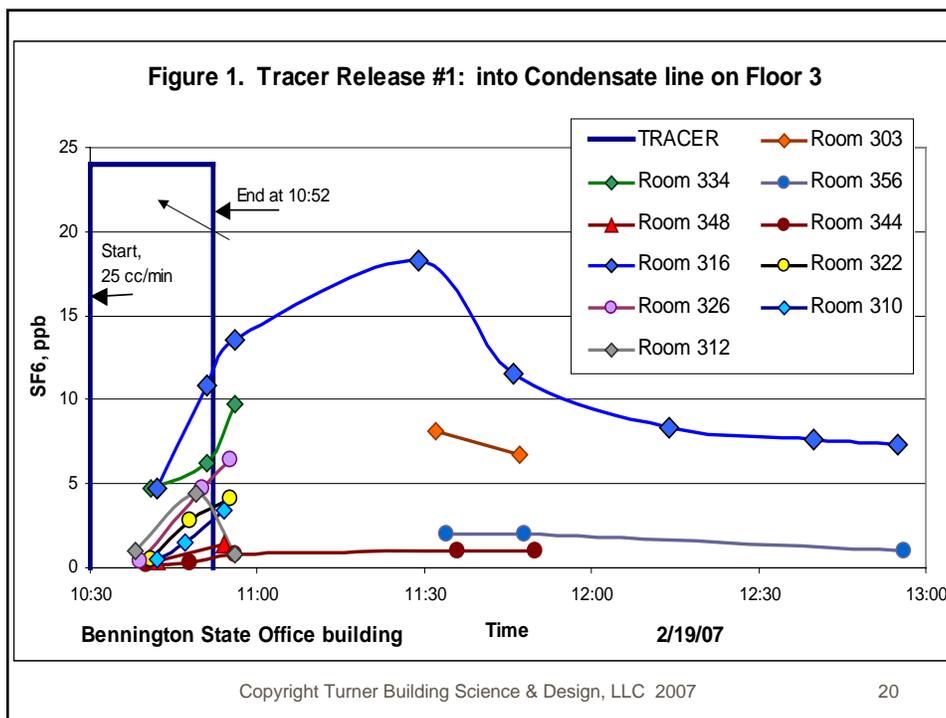
- **Results:** Multiple pathways confirmed, air moved into facility almost instantly in both drain lines tested 3rd and 2nd floor, then moved to other two upper floors within 20 minutes.
- **Info. Appendix. #C3, Figure 1,2,3**
C.A.R.: #1, #10 Replace the HVAC Systems, clean the facility.

Figure 2. Tracer release #1 into Condensate Line on Floor 3
